FACILITY COMPLIANCE INSPECTION REPORT

Division of Waste Management Solid Waste Section

Chatham County LCID Landfill
720 County Landfill Road
Pittsboro, NC 27312

Comprehensive Audit (to ensure that the notified land clearing and inert debris (LCID) landfill is in compliance with 15A North Carolina Administrative Code (NCAC) 13B .0563, .0564, and .0566)

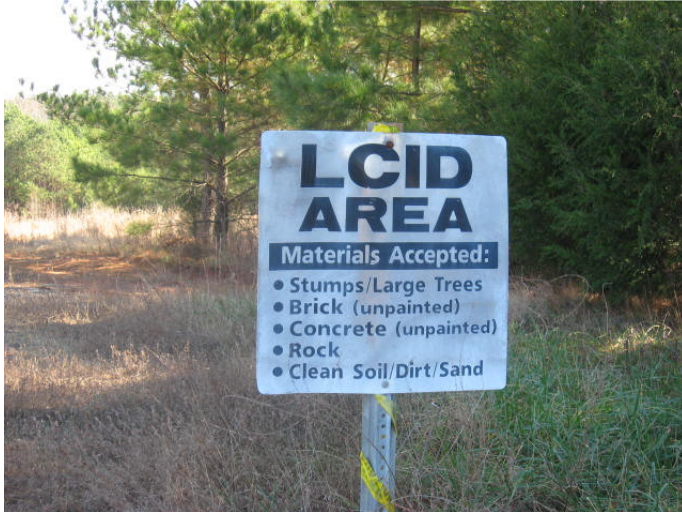
LCID landfill sign (contact information at facility entrance)

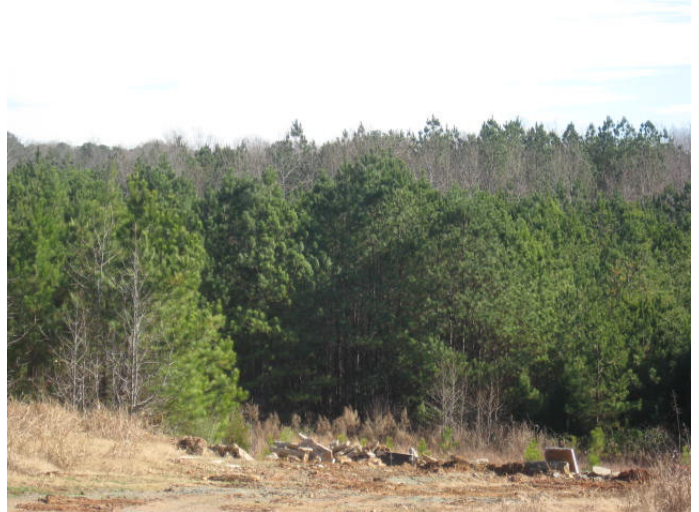
View of working face across top of landfill area

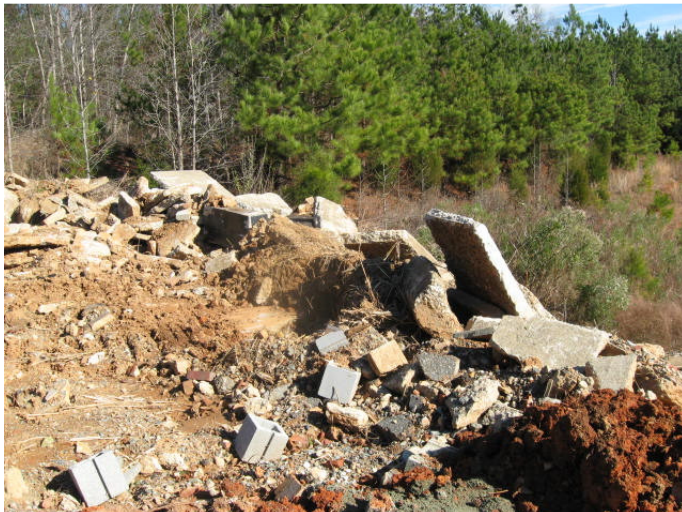
View of working face/side slope (need to cover with soil and grade accordingly)

3. Mr. LaMontagne stated that the LCID landfill only accepts inert debris. Land clearing debris (LCD) is diverted to the yard waste compost operation.
4. Per 15A NCAC 13B .0566(4), "Adequate soil cover shall be applied monthly, or when the active area reaches one acre in size, whichever occurs first."

5. Side slopes should be graded and covered with soil such that a 3:1 slope ratio is obtained or a ratio of which no indication of erosion or runoff is observed.

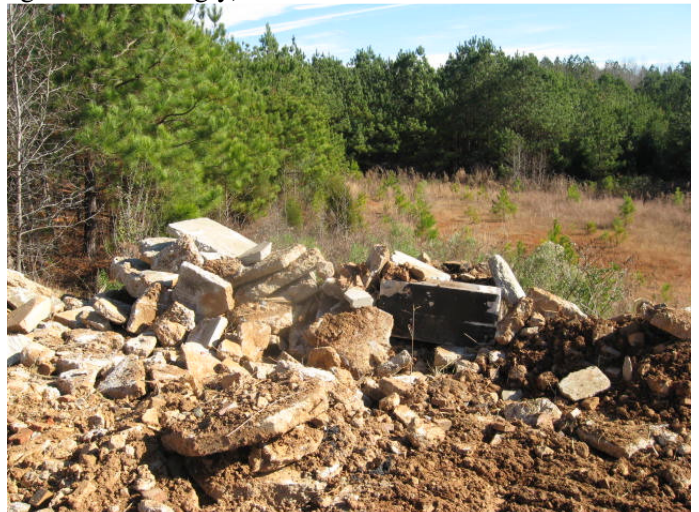
View of large painted cement block at working face/side slope (need to remove block, cover with soil and grade accordingly)

6. Remove the large painted cement block and metal pipe pieces filled with cement.
7. There was no indication of erosion or runoff.
8. Access roads are of all-weather construction.
